**SAS Superstructure**

Location: 04-SF-80-13.2 / 13.9

**Daily Diary Report by Bid Item**

Diary #: 009 Const Calendar Day: 899 Date: 24-Feb-2012 Friday

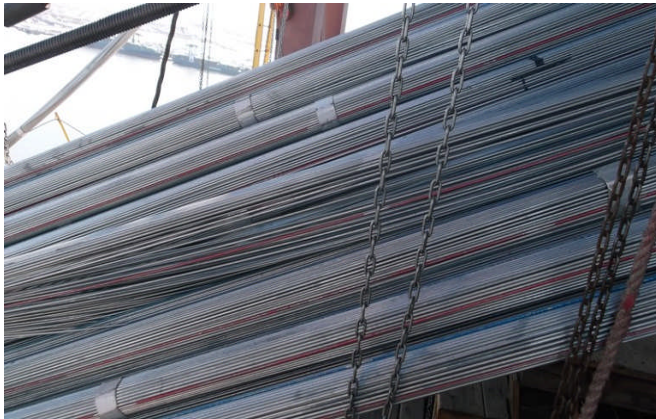
SlackOnStrand58South(2)

- RA Strand #58 South at 9:44: moving 1360mm to the East with a lot of slack wires coming out of the saddle.
- On this adjustment, with no one driving the wood block, yet again, the wood block moved up immediately resulting in the bulging up of wires and the banking of this strand as shown in the photos. The 2nd RA of Strand #58 South resulted in a net measurement of 1305mm, which means the strand moved back 55mm to the West. This 2nd adjustment did not result in additional banking of the strand as all the damage (banking) had been done already, during the 1st rough adjust.
